# *Resistance of Exterior Walls to High Velocity Projectiles*

*Jan 2001*

Canadian Masonry Research Institute  
#200, 10524 - 178 St.  
Edmonton, AB  
T5S 2H1

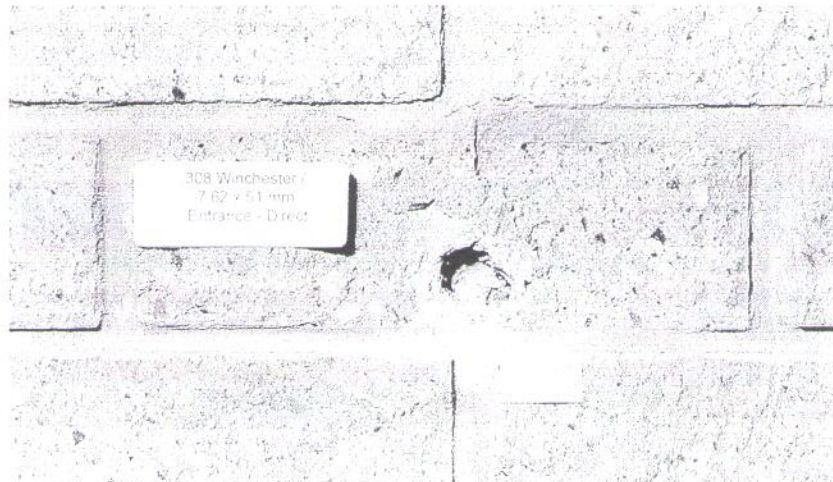
Figure 4 - Damage to concrete brick caused by .308 Winchester

The .308 Winchester bullet removed a region approximately 100 mm wide by 55 mm high. The hole was 25 mm by 20 mm to a depth of approximately half the brick thickness. This damage is shown in Figure 4.

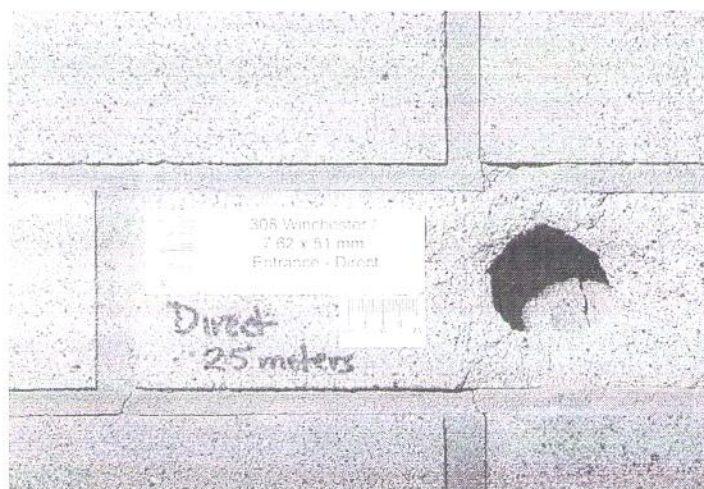
Figure 3 - Damage to clay brick caused by .308 Winchester

The .308 Winchester bullet fired at a 45 degree angle chipped a out a piece approximately 100 mm wide by 55 mm high from the front of the brick. The bullet created a circular hole approximately 50 mm in diameter and became lodged in the center of the brick. This impact also fractured the brick in many places that were not visible from the outside of the wall. Figure 3 shows the damage caused by the .308 Winchester upon direct impact.
